DIAMANT

SERVICE

BULLETINS

S E R V I C E - B U L L E T I N

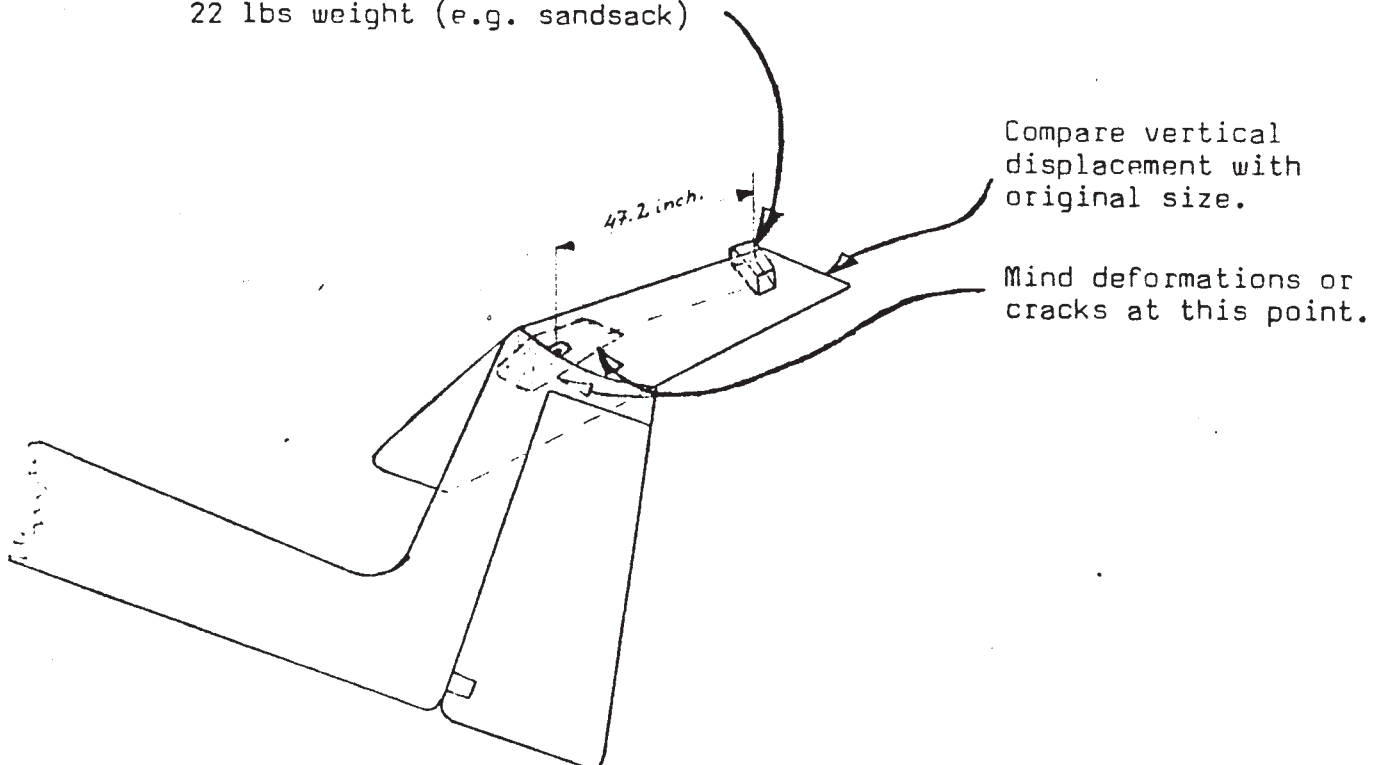
Reason : By violent turn landing damage occured on the inside web of the horizontal tail which is recognizable in a strike softness of the horizontal tail.

In a distance of 47.2 inch. (1200 mm) from the center the horiz. tail shall be loaded with 22 + 33 lbs (10 + 15 kp). The skin of the empennage in the area of the mounting is to be inspected for detached points and also for deformations and cracks.

Further, the vertical displacement of the empennage leading edge shall be mind.

If there is any damage on the empennage it has to be send immediatly to the nearest workshop or to FFA for repair.

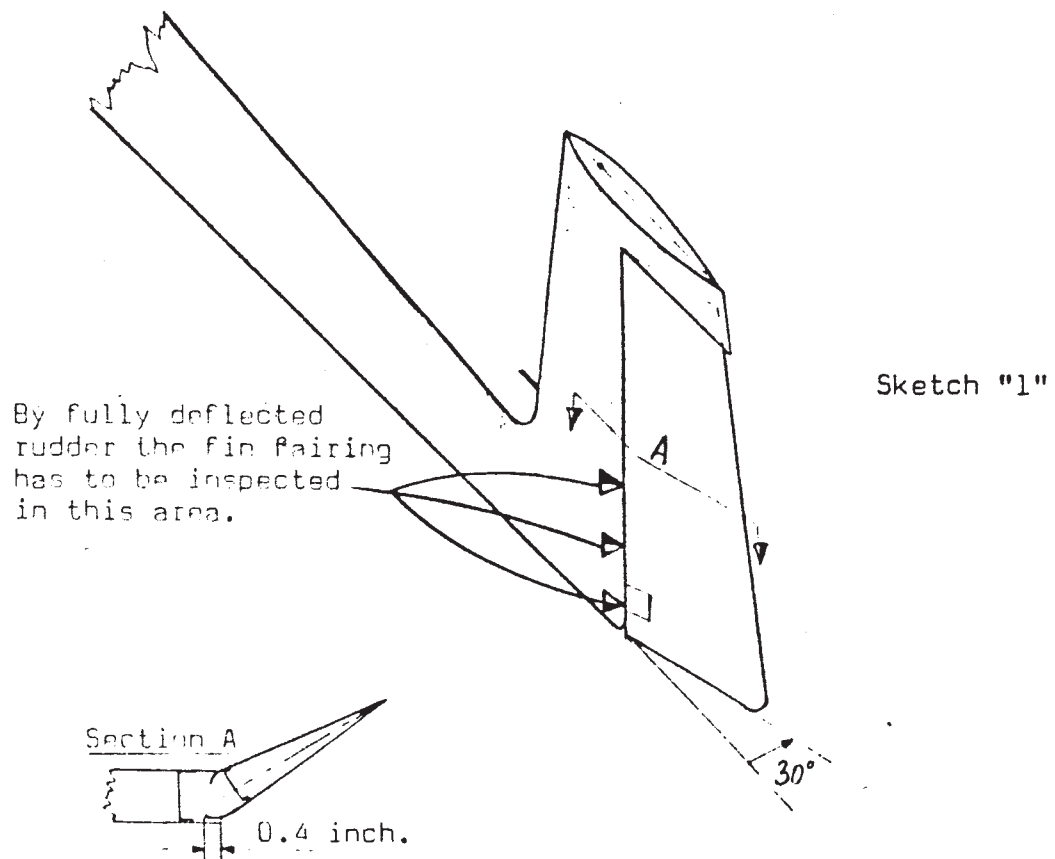
Reason : By fitting on the rudder of the vertical empennage some of the left fin hinge fairing were cut very small, so that a simultaneous pressure on the fairing and an extreme rudder position can result in their jamming.

The rudder shall be fully deflected to the right, so that the left fin fairing can be inspected in accordance to the sketch "1".

If the covering is smaller than 0.4 inches (10 mm) the rudder nose has to be lengthened with 3 strips of fiberglass as shown in sketch "2". The bonding area has to be grinded before bonding.

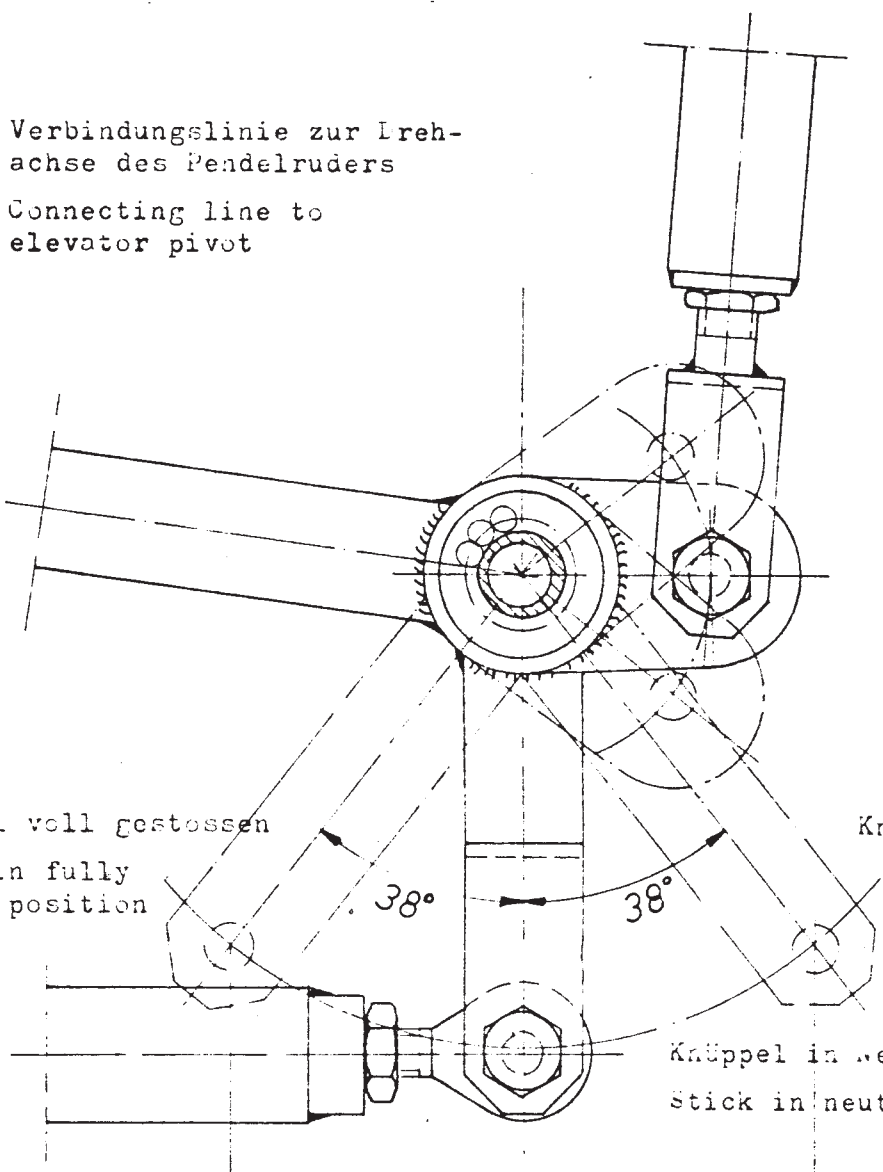
HOEHENSTEUERUMLENKHEBEL
ELEVATOR BELLCRANK

Reason: We have experienced a failure of the threaded end of the bearing rod end at the end of the elevator pushrod in the fuselage where the pushrod is connected to the bellcrank at the base of the fin.

Due to improper adjustment of the elevator pushrods in the fuselage, the position of the bellcrank lever was such that the fork of the bellcrank touched the threaded end or the threaded bushing in the fully pulled position. The threaded end was deformed and eventually failed.

Check if the driving lever of the bellcrank lever is in vertical position when the stick is in neutral position. The driving lever should attain the full travel as indicated on the attached drawing.

If the travel has to be adjusted, proceed as mentioned in the REPAIR MANUAL, Section 8.5.

Check threaded ends for deformation and indentations and ensure that they are screwed in far enough and all lock nuts are tight and lock washers installed as required.

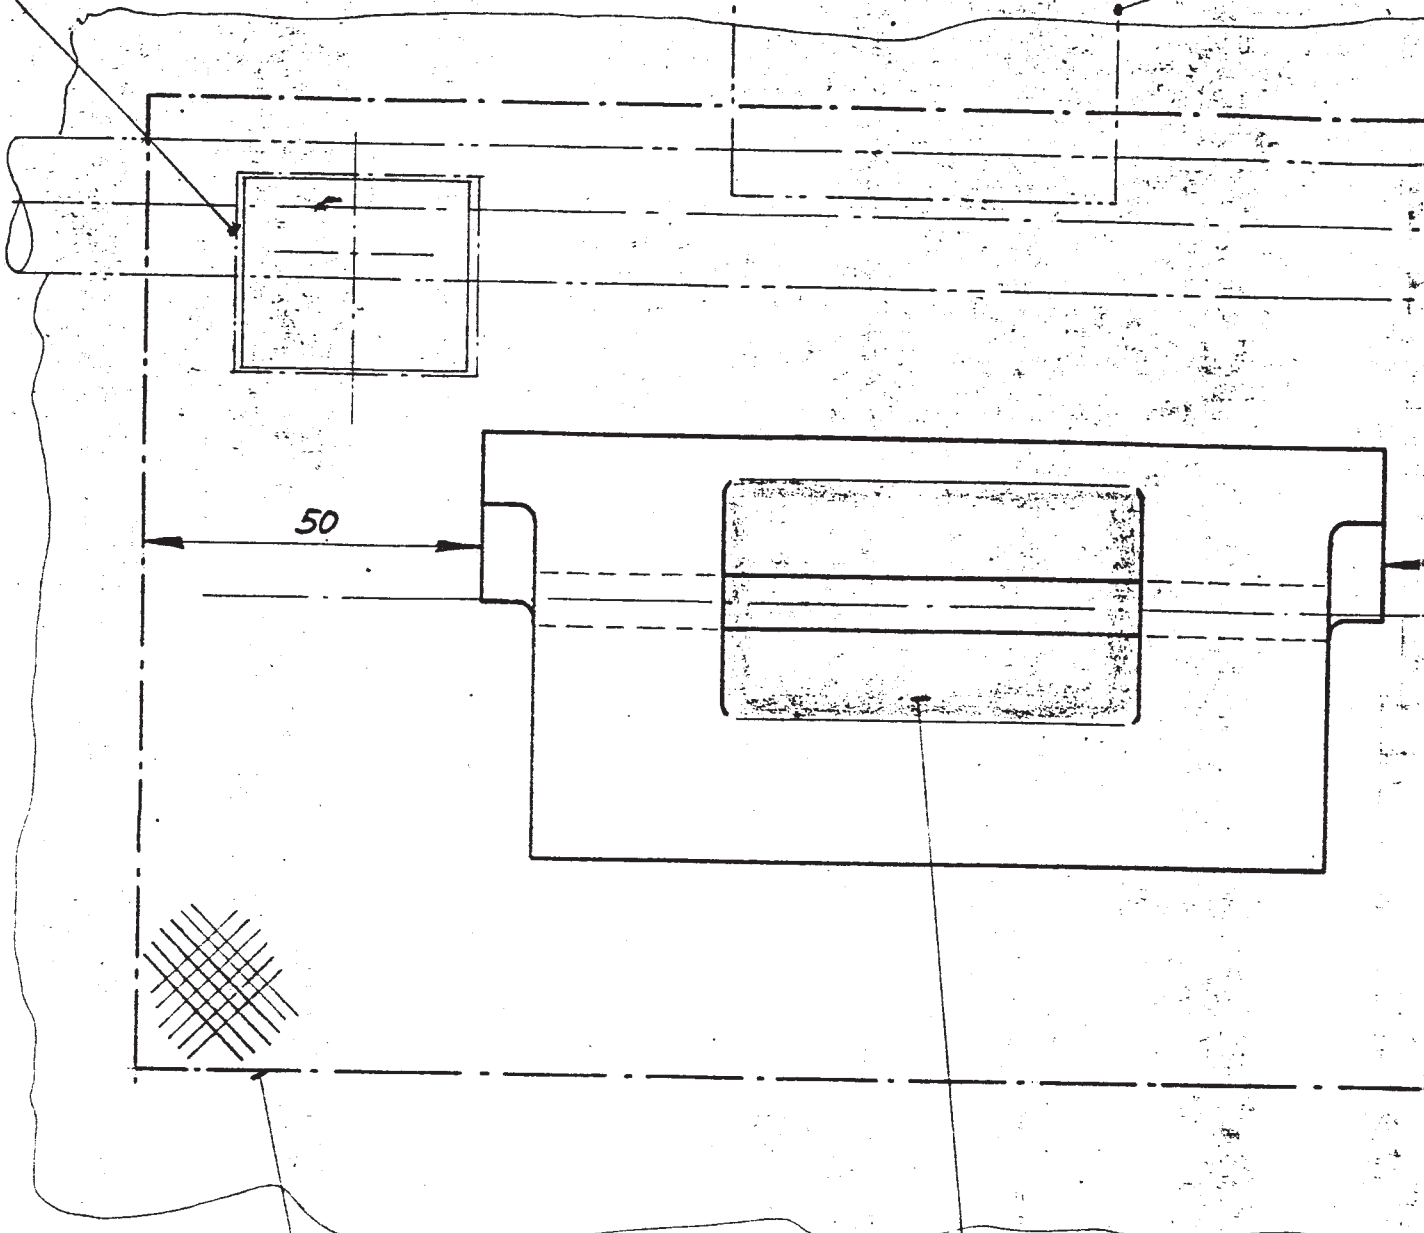
REASON : The lower harness attachments of a DIAMANT sailplane came loose due to an incident. The investigation showed that the bonding of the attachments was insufficient.

Bei Trimmhebellagerung (rechts) ausscheiden
 CUT OUT AT TRIM CONTROL LEVER SUPPORT (RIGHT)

2 Gewebe ~~X~~ auf laminiert
 2 FABRICS ~~X~~ LAMINATED

Nach dem Laminieren aussc
 TO BE CUT OUT AFTER LAMIN

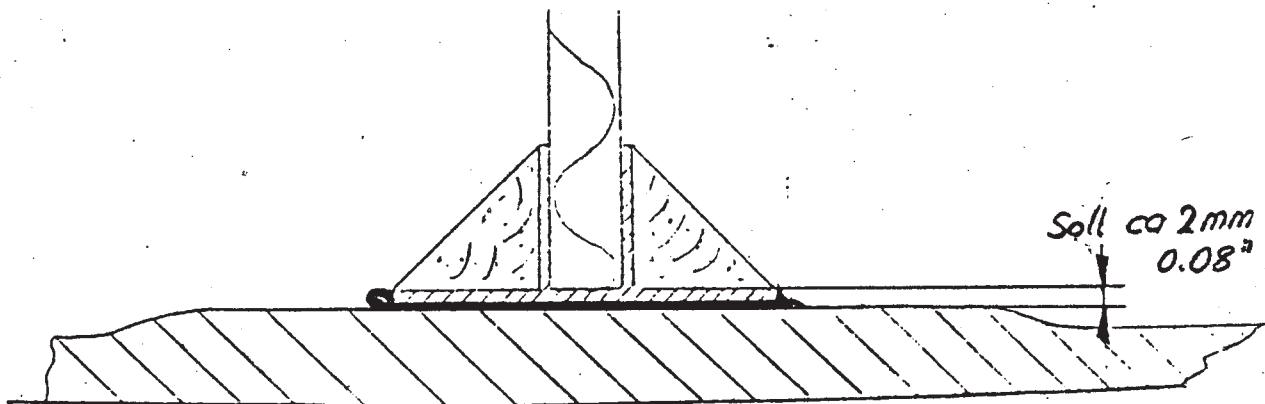
1. Lay wings on trestles the right way up.
2. Remove covers in bottom wing panel
3. Insert strip lamp through holes in root rib.
Inspect forward facing bonding seams up to tank rib,
rearward seams up to 9 ft from root rib.
Inspect bonding seams directly or by means of the angled mirror
through the access holes in the root rib using the following criteria:
 - 3.1 The bonding may be considered to be satisfactory, if the resin has oozed, often in drops, out of the bonded joint. The height of the hat section flange should be less than 0,08" above the skin panel surface to ensure a thin bonded joint.

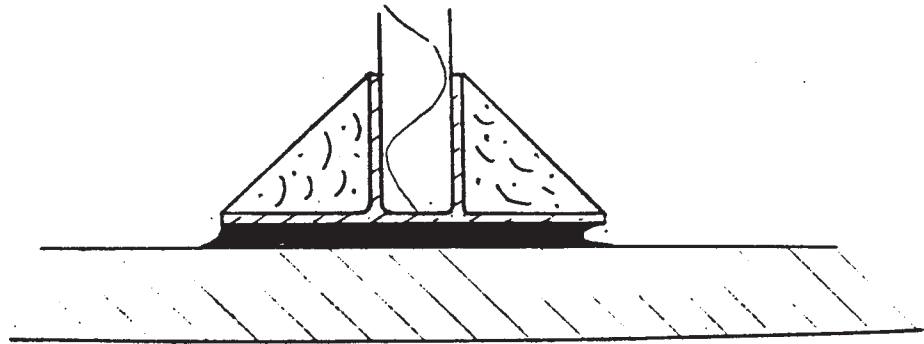
- 3.2 Overthick bonded joints may well include entrapped air bubbles, if the resin had not been properly squeezed out. Receding glue line must be viewed with suspicion. In both these cases a repair according to Appendix II must be carried out. The extent of the fault will be determined by means of probe drillings. Probe drillings shall be carried out within the suspected area, starting from inboard, in accordance with para. 4.

- 3.3 If receding glue line is detected, estimate depth of same with probe hook and mark spanwise position on opposite wing surface. Repair according to Appendix II of this Service Bulletin.
