DIAMANT

SERVICE

BULLETINS

S E R V I C E - B U L L E T I N

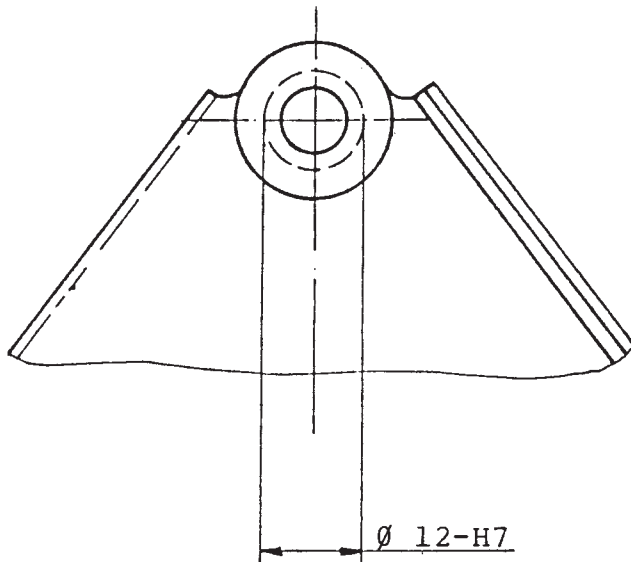
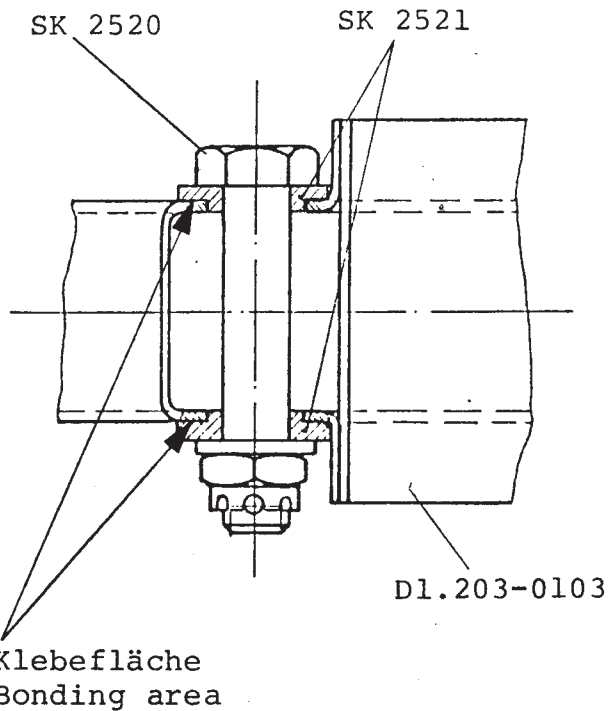
Reason : The stick control of one DIAMANT sailplane had too much play. The result of an exact investigation was showing wear of the stick bearing in the torsion tube.

Klebstoff:

Loctite No. 40
oder
Araldit Harz AW 106
Härter HV 953U

Adhesive:

Loctite No. 40
or
Araldit Resin AW 106
Hardener HV 953U

Klebeanweisung:

1. Klebeflächen von Farbe, Oel, Fett und anderen Rückständen reinigen.
2. Klebemittel auftragen.
3. Lager-Büchsen einpressen.
4. Ueberflüssiges Harz von der Innenseite entfernen und Bohrungen sauber halten.

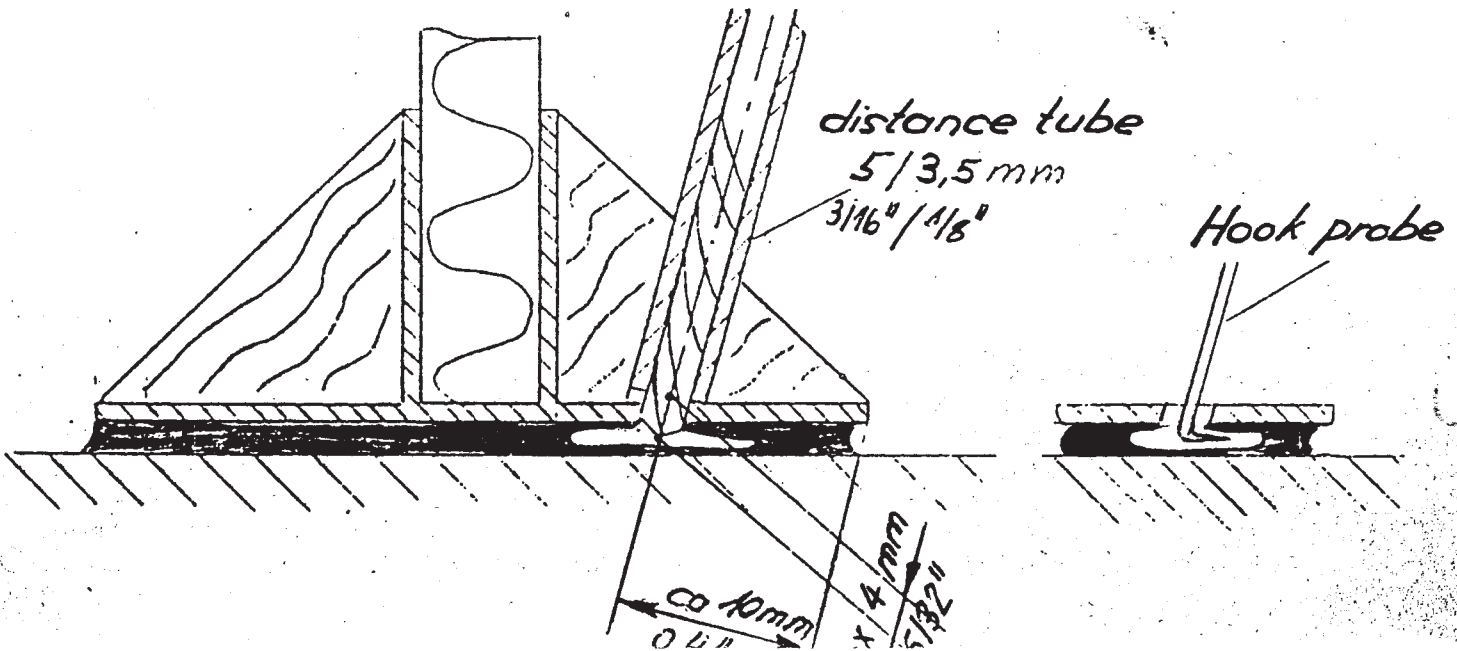
- 3.2 Overthick bonded joints may well include entrapped air bubbles, if the resin had not been properly squeezed out. Receding glue line must be viewed with suspicion. In both these cases a repair according to Appendix II must be carried out. The extent of the fault will be determined by means of probe drillings. Probe drillings shall be carried out within the suspected area, starting from inboard, in accordance with para. 4.

- 3.3 If receding glue line is detected, estimate depth of same with probe hook and mark spanwise position on opposite wing surface. Repair according to Appendix II of this Service Bulletin.

- 4.1 Find chordwise spar cap edge position by tapping upper surface with pencil, observe the change of note and mark.
- 4.2 Drill 0,2" dia. hole (avoiding spar cap) in wing surface opposite to the suspected area.

- 4.3 Using long 1/8" dia. drill, slip over a 3/16" distance-tube, so that the drill point protudes 5/32".
- 4.4 Drill 1/8" dia. hole into foam corner fillet of hat section, through hat section flange and into thick joint according to figure below. Cavity will be felt when drilling. If not, introduce "short" probe hook and see if cavity can be felt.

- 4.5 Repeat probe drillings cca. 1 in inboard and outboard of the first hole using the same hole in the upper wing skin.
- 4.6 Repeat steps 4.2 through 4.6 using a new hole drilled 3" outboard of the first hole in the top surface, to be repeated until the range of the suspected joint defect has been covered.
5. Where no cavities have been found, the holes may be filled in after completion of operations of Appendix III.
6. If cavities have been found, repairs according to Appendix II of this Service Bulletin must be carried out.

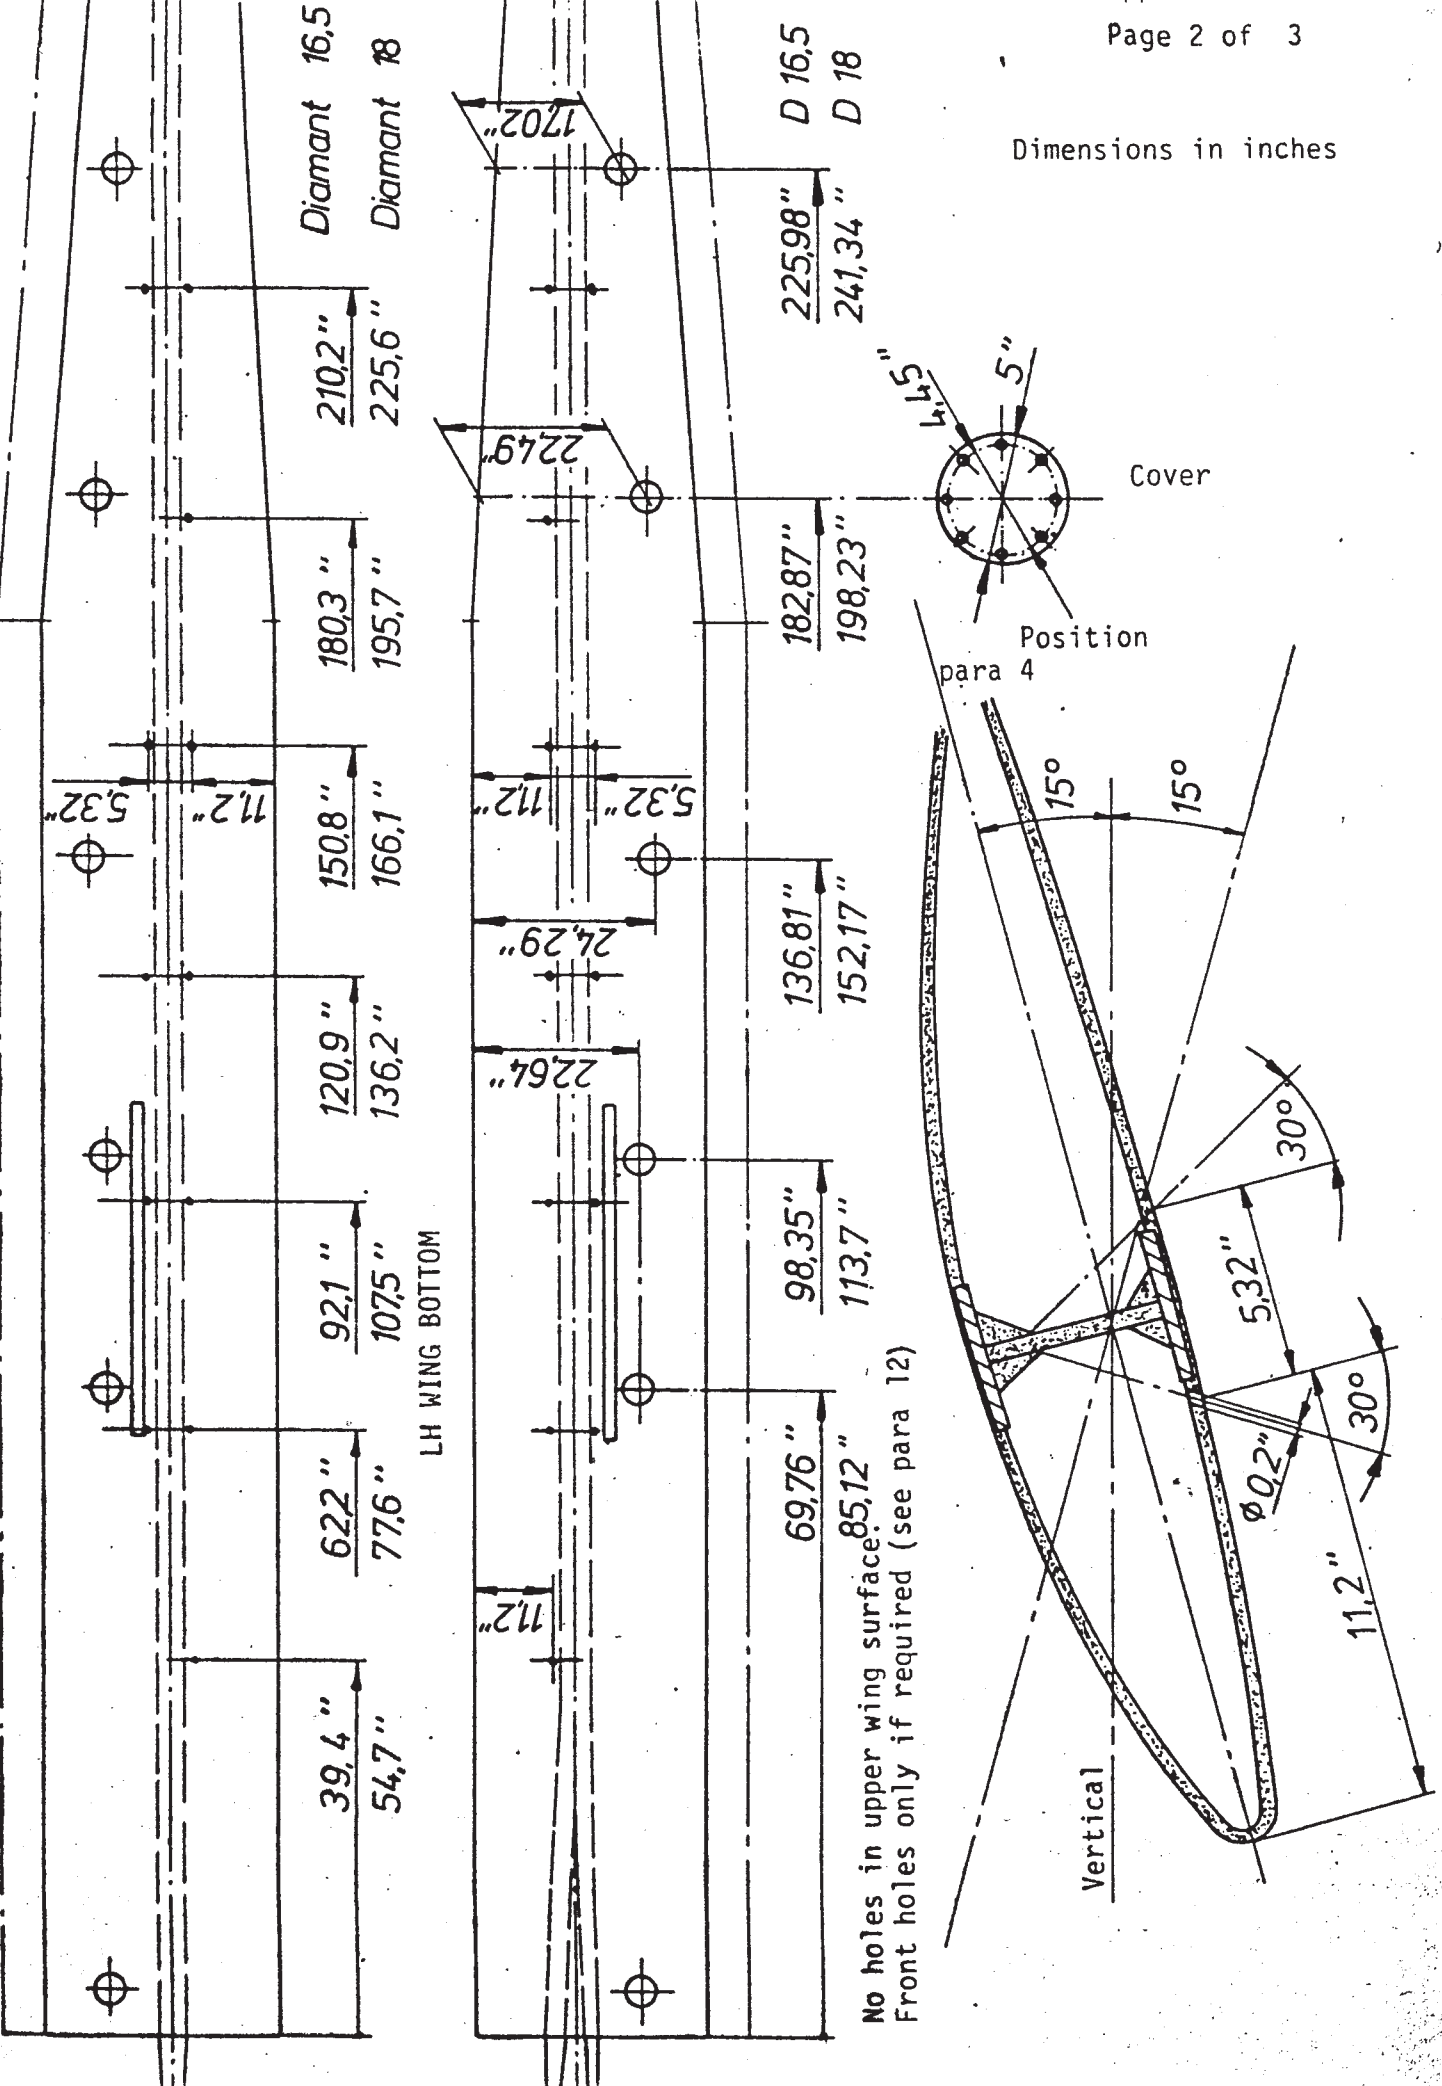
LH WING BOTTOM

No holes in upper wing surface.
Front holes only if required (see para 12)

11. After curing tilt wing back to 75 degrees and apply resin mixture to the leak point using nearest hole. Leave for 4 hours.
12. If gap between web and hat section is existing on forward face of spar (visible through hole in root rib), drill holes in front of spar, turn wing to 75 degrees nose up position and repeat procedure of para. 6 to 11 using the forward holes. There should be no more leakage of resin. Keep wing in this position for 4 hours at 20⁰C minimum.

13. Fill the 3/16" holes with microballoon/resin mixture after leveling the wing the right way up. Cover over holes with plastic tape.
14. Patch up the 7 x 3.2 in access holes, if required in Appendix II, according to Repair Manual section 3, page 5 :
