Report No.: FV - 816

Issue: February 1968

R E P A I R M A N U A L

Sailplanes DIAMANT HBV, 16.5 and 18

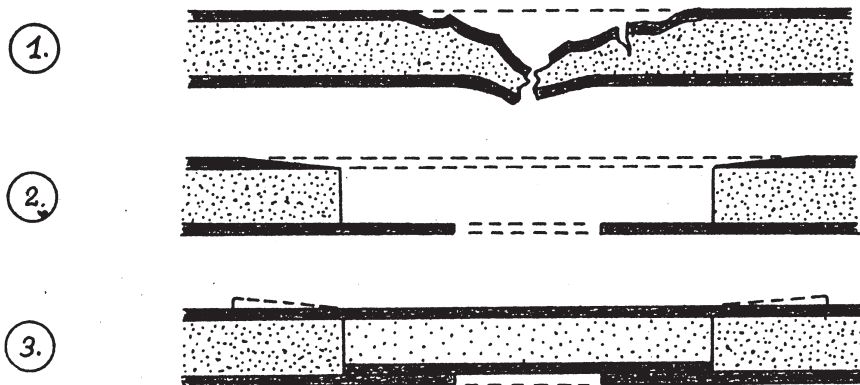
- cut out the foam core with oversize, so that the inner sandwich skin protudes all around about 3/4 in. (see figure 2).
- Grind edge taper of about 1 inch width at the borders of the outside fiberglass skin (see figure of section 3.1.1).

- Coat the bonding area with resin and place the so prepared panel into the prepared repair spot (see figures 2 and 3).
- Fit in foam core material and resin-bond.
- Continue as described in section 3.1.2 and 3.1.3.

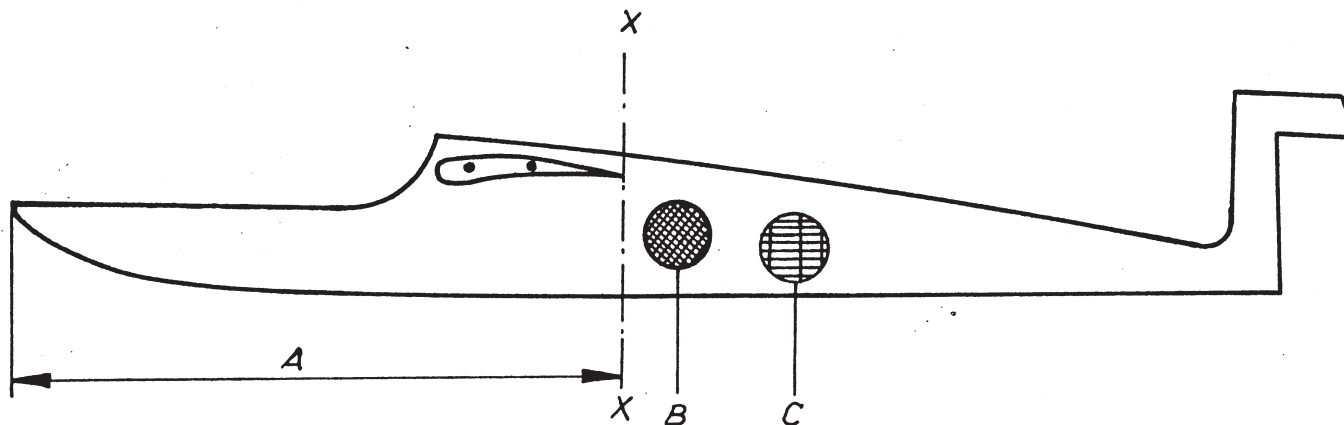
4.1 Fuselage

- For repairs to the outer sandwich skin on the outside of the fuselage: First 1 layer of fabric no. 140 diagonally (B), and then 1 layer of fabric no. 143 lengthwise (C), are to be laminated onto the foam core.

This is valid for the whole length of the fuselage.

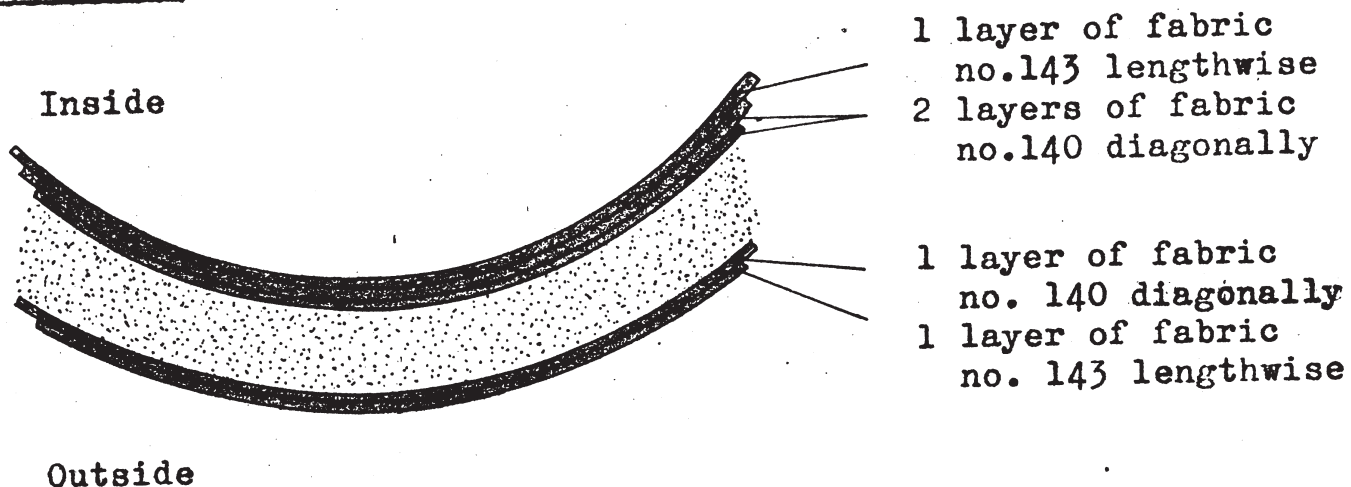
Example for area A:

- For repairs to the inside of the fuselage within the area of the fuselage nose to the end of the wing trailing-edge (place X) 2 layers of fabric no. 140 diagonally and, on top of that, 1 layer of fabric no. 143 lengthwise are to be laminated onto the foam core.

In the area from spot X to the fuselage end only 1 layer of fabric no. 140 diagonally, and, on top of that, 1 layer of fabric no. 143 lengthwise, are to be laminated onto the foam core.

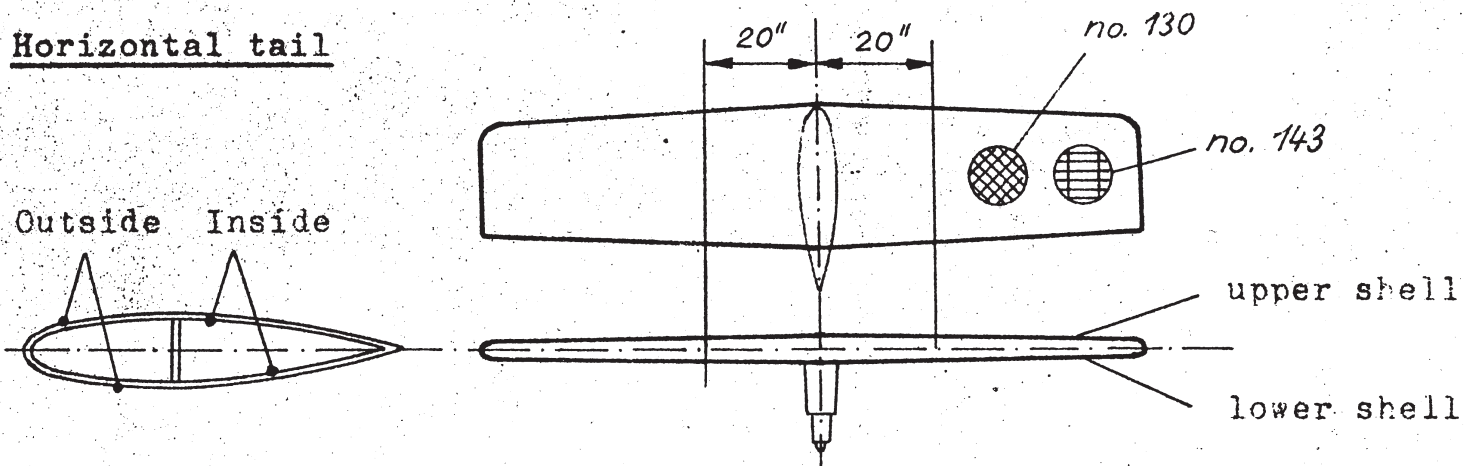
### 4.2.1 Horizontal tail

For repairs of the horizontal tail, use for the outside sandwich skin in the area from the centerline to a line 20 inches outward 3 layers of fabric no. 143 in span-wise direction, on top of these 1 layer of fabric no. 130 diagonally, and as cover 1 layer of fabric no. 143 in span-wise direction. Laminate these layers onto the foam core.

Use for the outside sandwich skin outward of 20 inches from the centerline as well as for the whole inside sandwich skin 1 layer of fabric no. 130 diagonally, and as cover 1 layer of fabric no. 143 in span-wise direction.

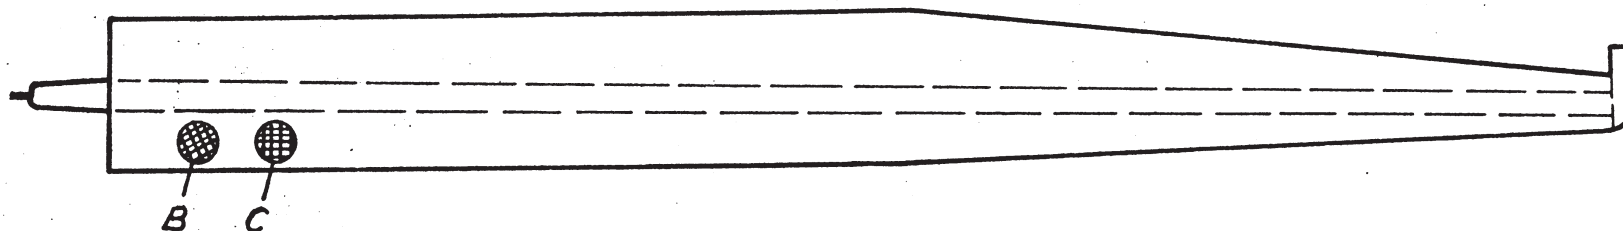
#### 4.4 WING (model 16.5 and 18 only)

For repairs to the outer sandwich skin of the wing 1 layer of fabric no. 140 diagonally (B) is to be placed onto the foam core and 1 layer of fabric no. 119 lengthwise (C) is to be laminated over it.

This is valid for the whole length of the wing.

For repairs of the inner sandwich skin 1 layer of fabric no. 140 diagonally is to be laminated onto the inside of the wing.

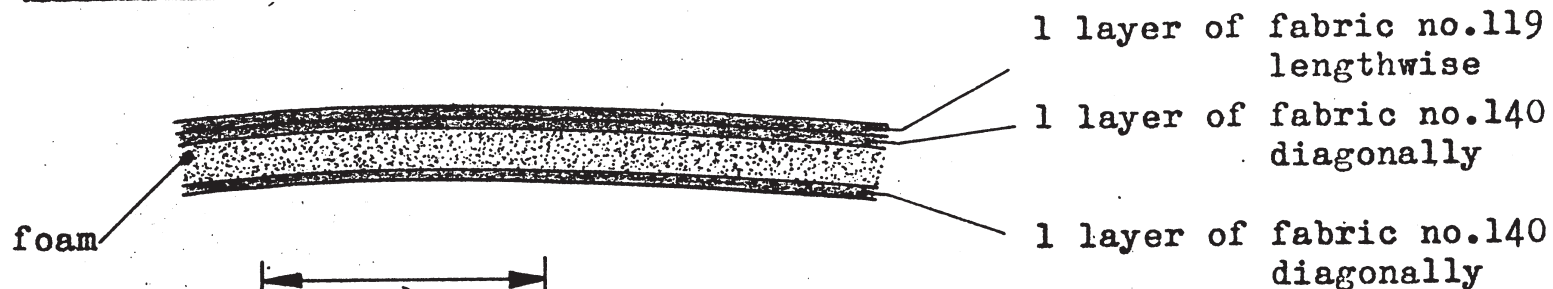
Wing shell

1 3/8 in. in the parallel part of wing,  
decreasing to 1/2 in. at the wing tip.

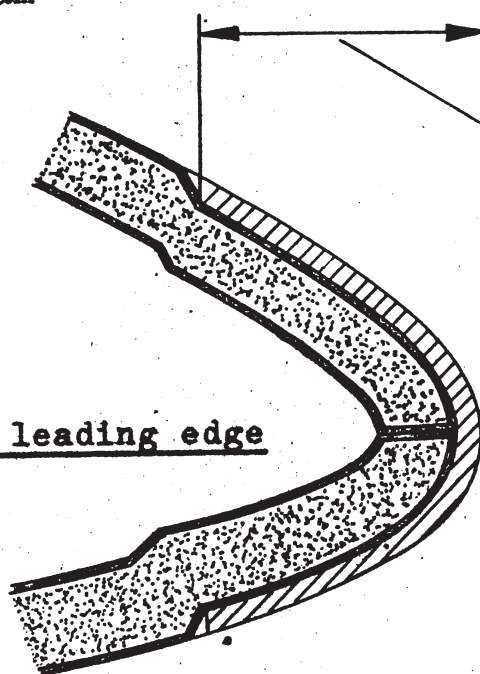
Wing leading edge

The reinforcement of the wing leading edge  
consists of fabric no. 140 diagonally only.

Damaged spots may be filled up with the  
matching fabric and resin that much that  
the shape of the airfoil section is regained

For repair of larger damage to the leading  
edge prefabricated reinforcements may be  
purchased from FFA.

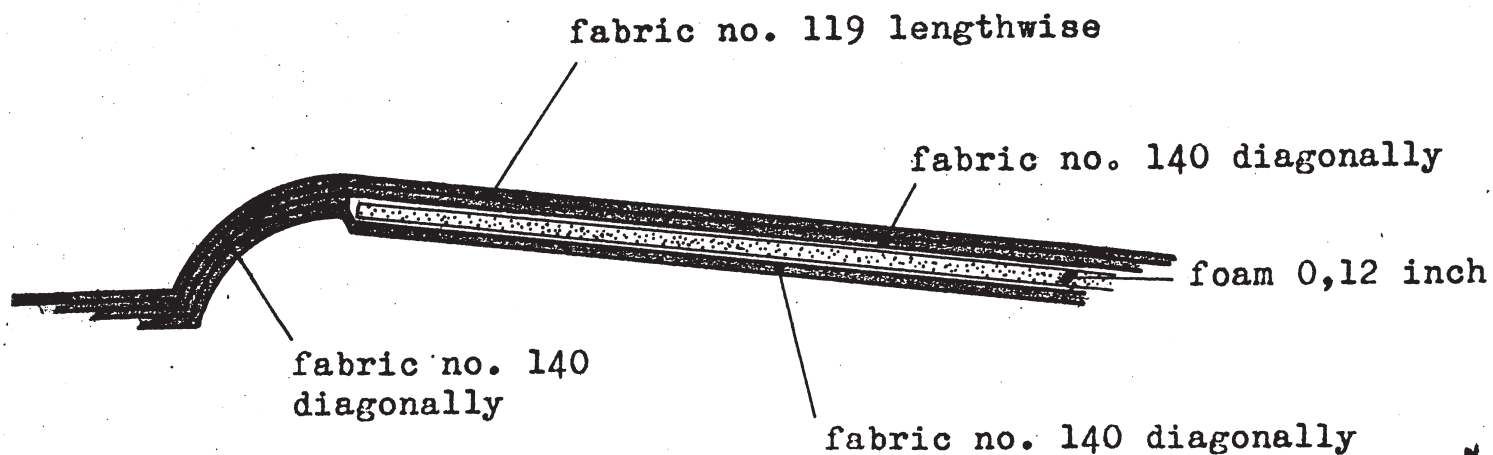
##### Aileron upper shell

##### Aileron lower shell (as upper shell)

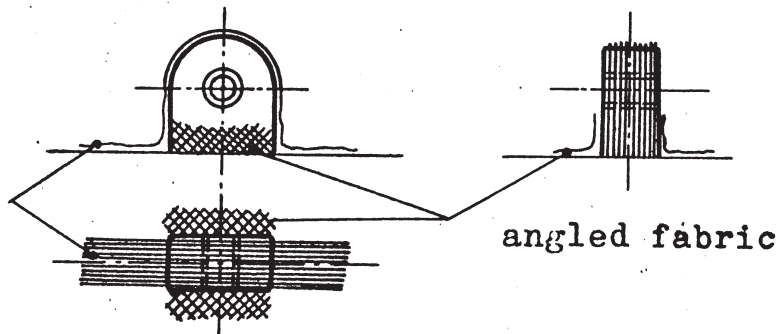
- The bearing block must be located and its position marked according to the repair drawings delivered by the manufacturer.
- The place where the bearing block is to be attached shall be cleaned and hand sanded.
- Glue the bearing block on with adhesive resin.
- Prepare resin mixture according to section 2.5.1
- Cut two roving strings and place according to sketch, across bearing block and resin-bond.
- Cut 1 fabric no. 140 on the diagonal and resin-bond into both sides of corners.

Rovings

angled fabric

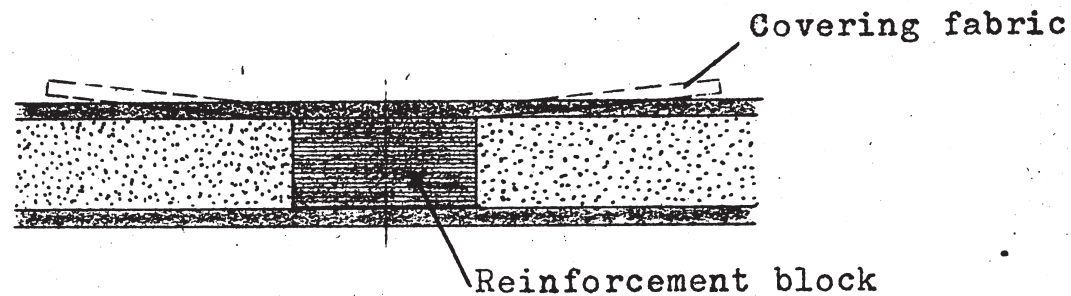
If a reinforcement block should break out, it must be replaced and bonded like a foam core repair.

Remark: Reinforcement blocks are reinforcements of the sandwich shell as mounting attachment for metal fittings. The foam core is replaced by a solid piece, prepared with layers of fabric and resin.

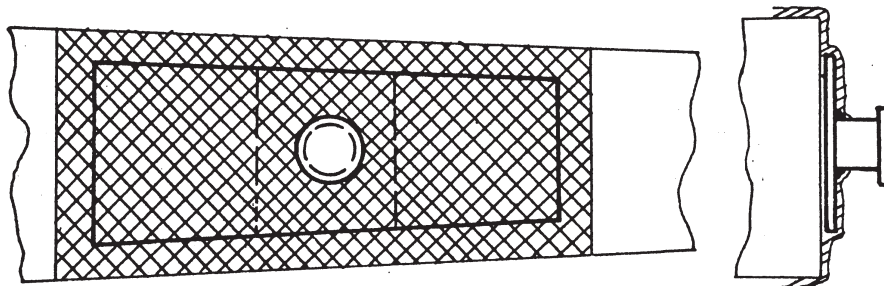
### 7.1 Mounting pin at the wing broken off

- Clean repair spot well and grind, without damaging the fiberglass.
- Clean mounting pin by hand sanding or sand blasting.
- Prepare mixture according to section 2.5.1
- Place mounting pin.
- Resin-bond, with 2 layers of glass fabric no. 140 on the diagonal, to spar. Cut small hole into glass fabric through which the pin will pass.

- Leave to cure for at least 24 hours (see section 3.1.2).

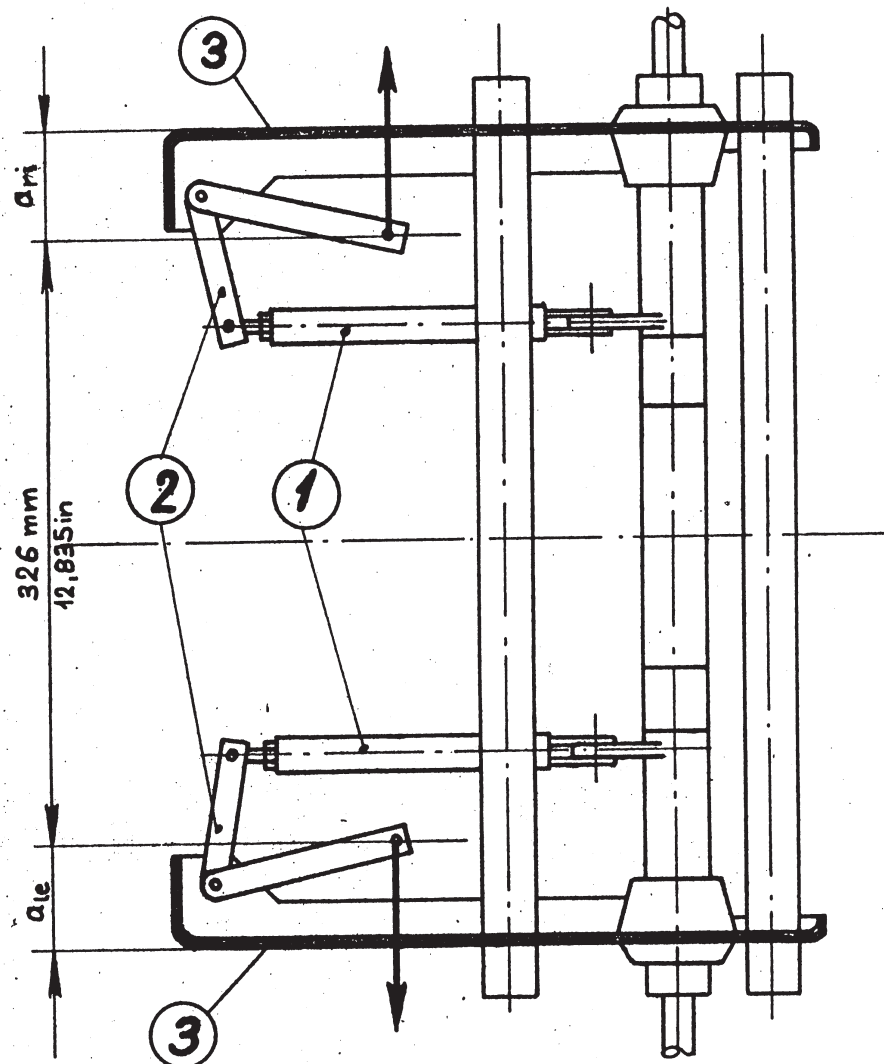
Figure to  
section 8.4

$a_{le} = a_{ri}$
